Pentium® III Xeon™ Processor Specification Update

Release Date: July 1999

Order Number: 244460-004

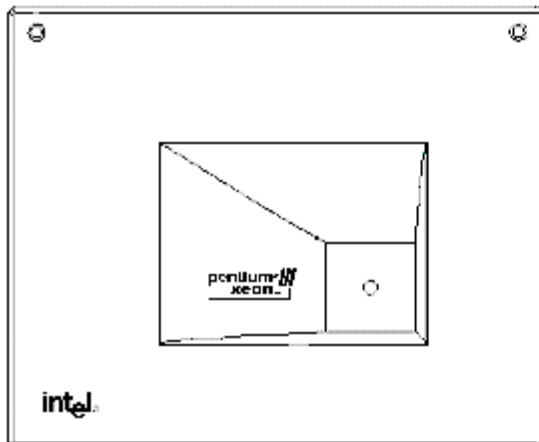
Pentium® III Xeon™ and Boxed Pentium® III Xeon™ Processor Markings

Production Dynamic Mark Example:

500/512/100/2.0V S1
 FFFFFFFF-NNNN {country}
 i®©'98 SSSSS

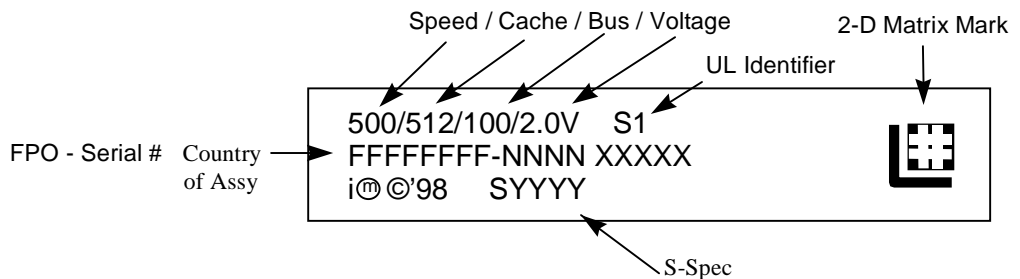
Dynamic Mark Area

Intel 80525PY500512
 FFFFFFFF-NNNN
